Application of acoustic emission in diagnostic of bearing faults within a helicopter gearbox

Elasha, F. , Greaves, M. , Mba, D. and Addali, A. (2015) Application of acoustic emission in diagnostic of bearing faults within a helicopter gearbox. Procedia CIRP, volume 38 (Proceedings of the 4th International Conference on Through-life Engineering Services): 30-36.

The Fourth International Conference on Through-life Engineering Services

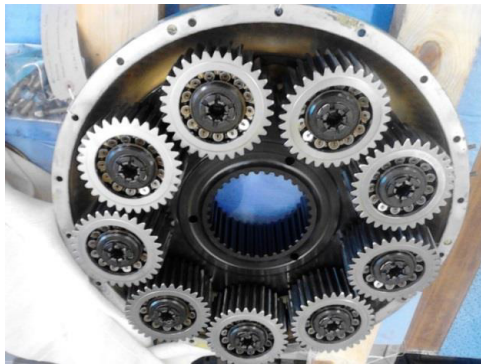
Figure 1 Second stage epicyclic gears

The main rotor gearbox consists of two sections, the main module, which reduces the input shaft speed from 23,000 rpm to around 2,400 rpm. This section includes two parallel gear stages. This combined drive provides power to the tail rotor drive shaft and the bevel gear. The bevel gear reduces the rotational speed of the input drive to 2,405 rpm and changes the direction of the transmission to drive the epicyclic reduction gearbox module. The second section is the epicyclic reduction gearbox module which is located on top of the main module. This reduces the rotational speed to 265 rpm which drives the main rotor. This module consists of two epicyclic gears stage, the first stage contains 8 planets gears and second stage with 9 planets gears, see figure 1. The details of the gears are summarised in table 1.

The epicyclic module planet gears are designed as a complete gear and bearing assembly. The outer race of the bearing and the gear wheel are a single component, with the bearing rollers running directly on the inner circumference of the gear. Each planet gear is 'self-aligning' by the use of spherical inner and outer races and barrel shaped bearing rollers (see Figure 1).

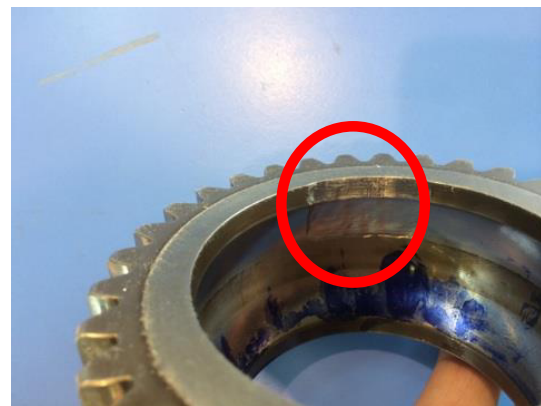
Figure 2 Slot across the bearing outer race

This investigation involved performing the tests for fault-free condition, minor bearing damage and major bearing damage. The bearing faults were seeded on one of the planet gears of the second epicyclic stage. Minor damage was simulated by machining a rectangular section of fixed depth and width across the bearing outer race (10mm wide and 0.3mm deep), see figure 2, and the major damage simulated as a combination of both a damaged inner race (natural spalling around half of the circumference) and an outer race (about 30mm wide, 0.3mm deep), see figure 3. Three load conditions were considered for the each fault condition, 110% of maximum take-off power, 100% and 80% of maximum continuous power; the power, speed and torque characteristics of these load conditions are summarised in table 2.

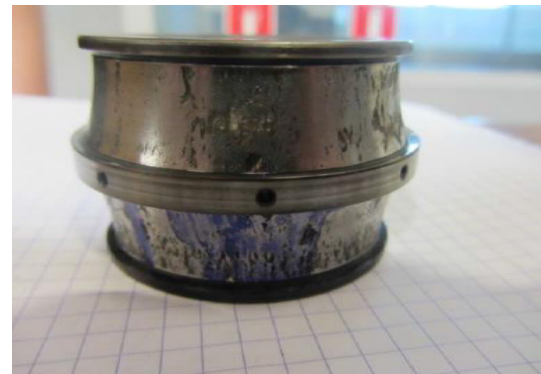
Figure 3 Inner race natural spalling

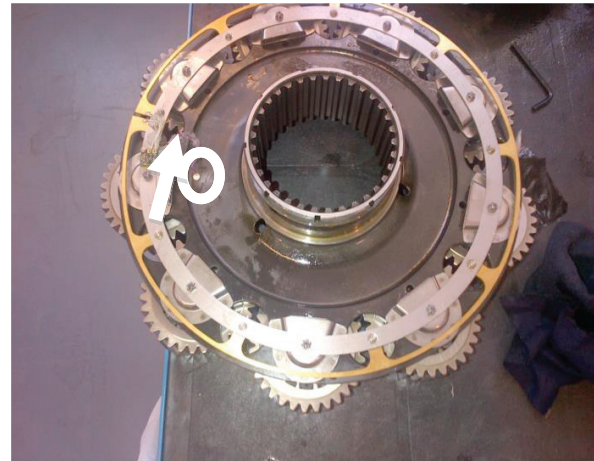
Figure 4 Moving coil mounted on the planetary carrier (coil arrowed, sensor circled)

Acoustic Emission data was collected using a PWAS sensor [46], 7mm diameter and approximately 0.2mm thick, bonded to the upper face of the planet carrier, see figure 4. The sensor was connected to a conditioning board attached to the planetary carrier and transmitted wirelessly using two coaxial copper coils and a new wireless transfer technique. The new wireless transfer technique utilise two single turn brass coils of approximately 400 mm diameter which were cut to size using water jets for accuracy. The stationary (upper) coil was suspended from two clamping rings which were

attached to the top case of the gearbox with a spacer through the holes to retain location. The moving (lower) coil was attached to a circular mounting ring which was in turn mounted on top of the oil caps on the planet carrier, see figures 4 and 5. Electrical isolation of the coils from the mounts and surrounding metallic structure was achieved through the use of nylon washers and bushes. AE data was acquired at a sampling rate of 5 MHz using an NI PCI-6115 card connected to a BNC-2110 connector block.

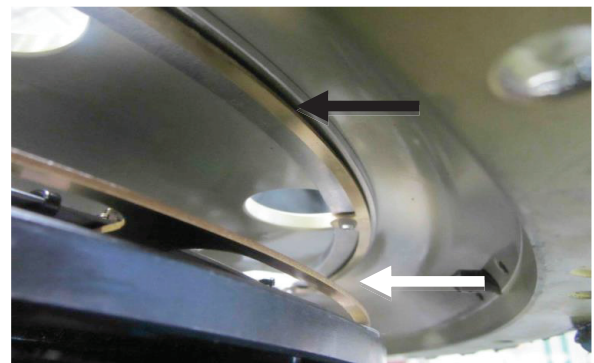
Figure 5 Coils in position prior to assembly (static coil black arrow, moving coil white arrow)

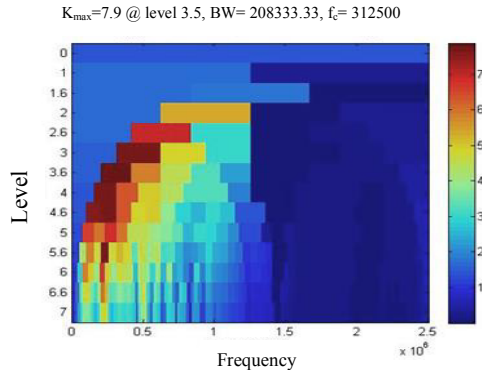
Figure 6 SK kurtograms major defects (110% maximum take-off power)

The Spectral Kurtosis was employed to extract the filter characteristics which were utilised for envelope analysis on measured AE signatures. Associated typical kurtograms of SK analysis are shown in Figure 6. The result of maximum kurtosis showed there were no noticeable differences between healthy and faulty conditions.

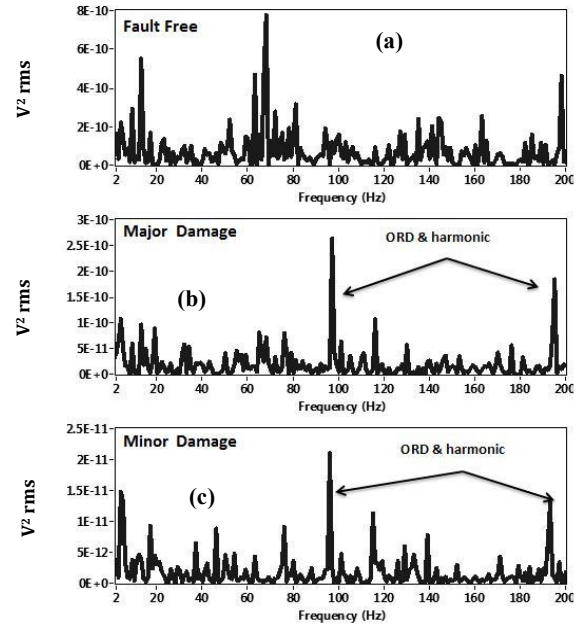
Figure 7 Enveloped spectra of AE signal (a) Fault-free (b) Major (c) Minor bearing defects at 110% maximum take-off power

table 4. Observations of figures 7, 8 and 9 showed the presence of the bearing outer race defect frequency (96 Hz) and its harmonic (192 Hz) for both minor and major damages under different loading conditions. The results showed the AE is very capable in detecting the faults of different sizes, in addition the results showed the defect amplitude increased significantly for major fault compared to minor fault, which provide measure for fault severity. Moreover, the fault detection was independent of load condition. However, comparisons of defect amplitude should be performed under similar condition.

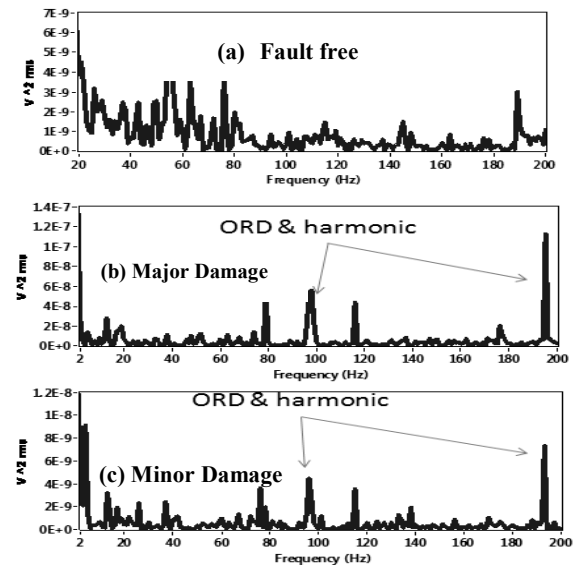
Figure 8 Enveloped spectra of AE signal (a) Fault-free (b) Major (c) Minor bearing defects at 100% maximum continuous power

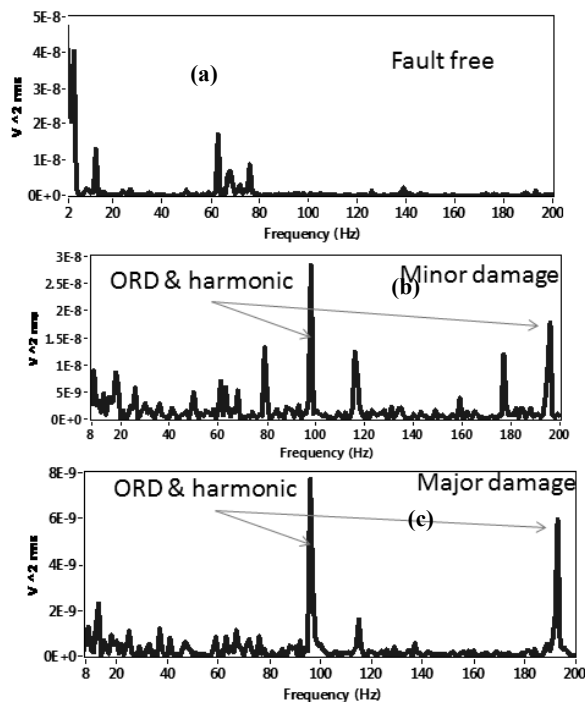
Figure 9 Enveloped spectra of AE signal (a) Fault-free (b) Minor (c) Major bearing defects at 80% maximum continuous power
